## **Restoration of the Great Theatre of Ephesos**

### **An Emergency Approach to Safeguarding the Monument and Making it Available for Partial Reuse**

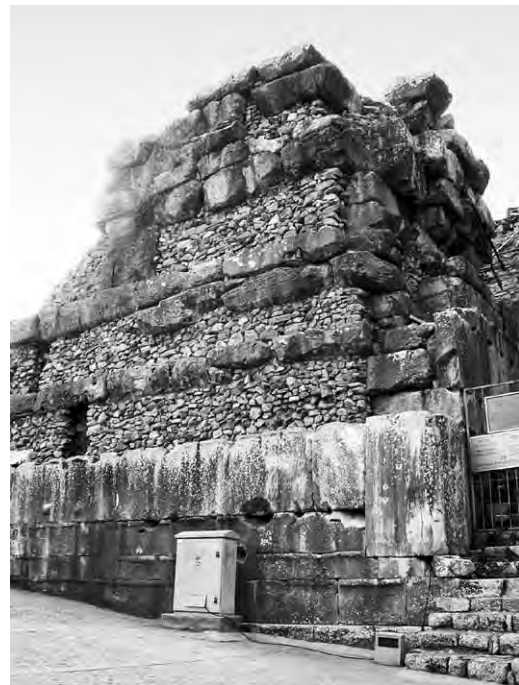
time. Structural interventions such as rubble walls built with cement based mortars to fill the missing sections (fig. 8) of load bearing walls have proven adequate until now. However such areas also need to be programmed into the maintenance program and inspected continually in order to prevent larger structural problems from arising.

8 Structural reinforcement of wall core using rubble stone and cement based mortars at the south *analemma*

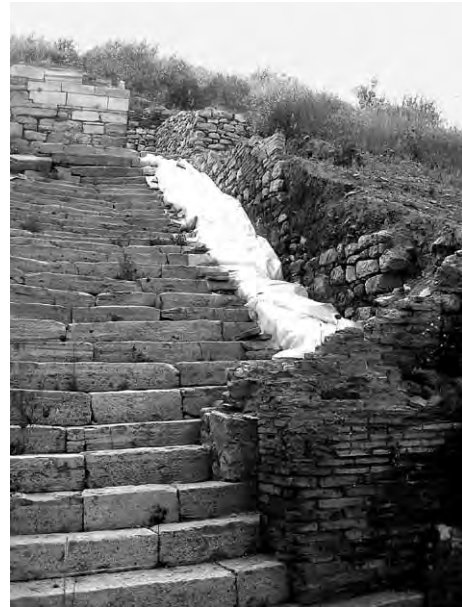
22 Staircase south of the Theater, condition before work

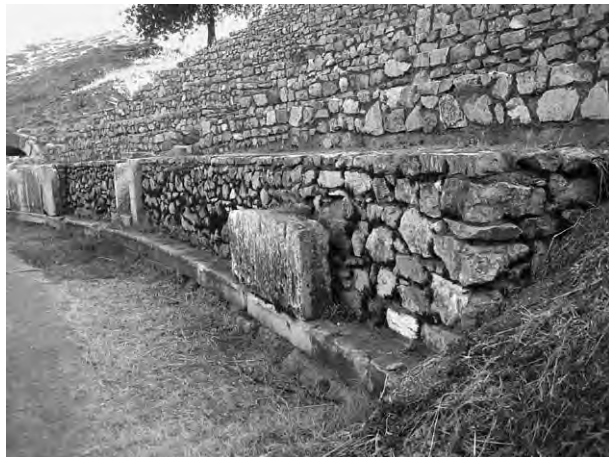
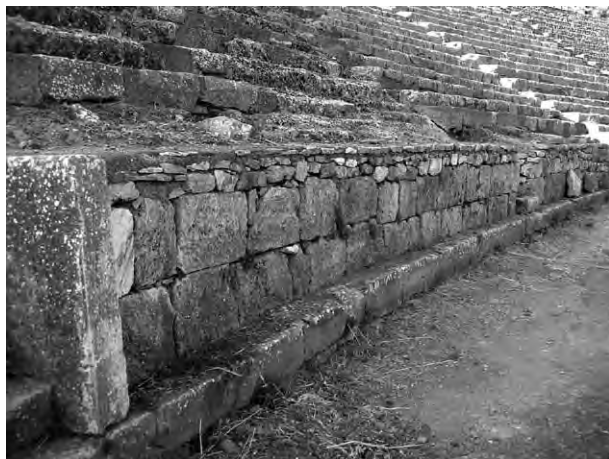
The walls of the second *diazoma* were infested with vegetation and insects and the cement based pointing from previous years was poorly done. Topsoil was discovered among the joints of the wall, indicating that previous interventions had been carried out without cleaning, and had captured soil inside the structure, causing deterioration from the inside. To understand the level of decay which might be caused by these factors, the cement joints had to be stripped to observe the original construction. An aesthetic problem due to the dark gray joints of the *diazoma* walls had also been noted before the beginning of the interventions. (figs. 23. 24).

23 Portion of the second *diazoma* wall before consolidation

24 Portion of the second *diazoma* wall before consolidation

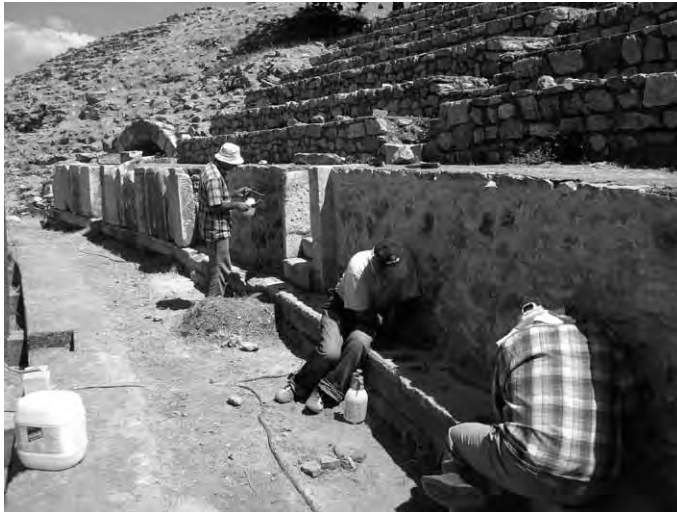
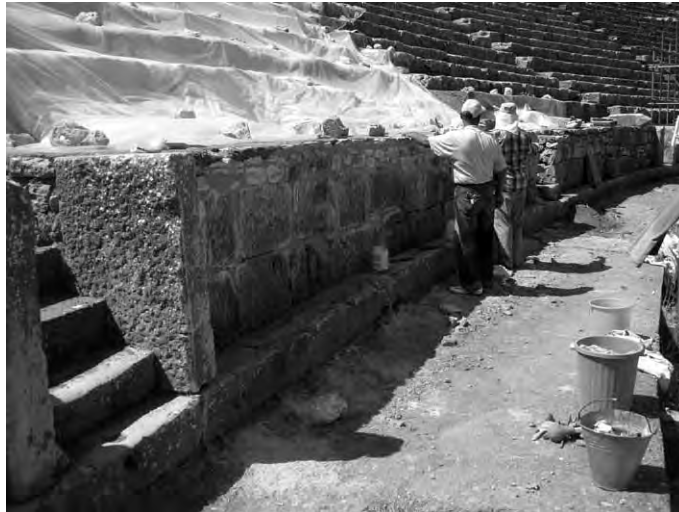
25 Second *diazoma* wall, after consolidation

26 Second *diazoma* wall, after consolidation

*Diazoma* walls of *kerkides* S6 through S19 were pointed, and all loose soil and infestation agents were removed. (figs. 25. 26). These interventions took place in the 2009 season.

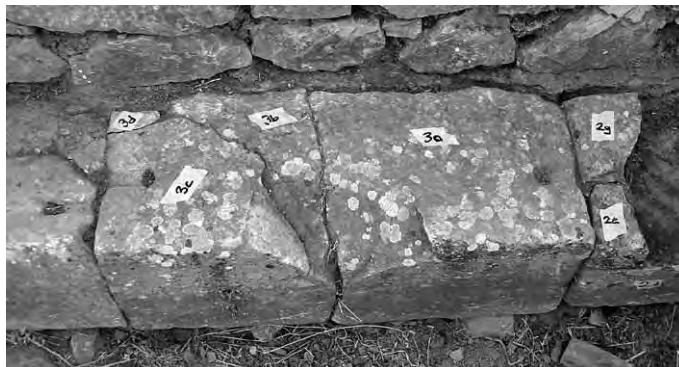
The pedestal blocks of *kerkides* S16, S17, S18 were discovered to have moved from their original locations due to soil accumulation, vegetation growth and pressure of cement mortar poured in the back during previous restorations. Several blocks were also found to be damaged and broken most probably due to problematic distributions of weight, original design problems (vertical use of sedimentation layers when stone is cut from the quarry) and serious salt cracks (fig. 27). It was decided to remove these blocks, apply necessary treatments and interventions to consolidate them to the strength of building blocks, and to put them back in place in their previously documented order; this time, however, in the proper position (fig. 28). The decision to put them back in the order they were documented is due to the fact that they seem to be not *in situ*, but placed in this order during a previous restoration phase, and at the moment it is not possible to determine the original order of the blocks.

27 A broken pedestal block of the second *diazoma*

The blocks were treated and cleaned to ensure that no loose material or calcareous incrustations are left in the surfaces to be adhered. Salt accumulations were partially mechanically cleaned, and unbroken salt cracks were investigated for continuity to prevent uncontrolled breaks. Cracks which could transform into breaks were detached under controlled guidance. Broken pieces were then put back together using epoxy-based adhesives and fiberglass dowels.

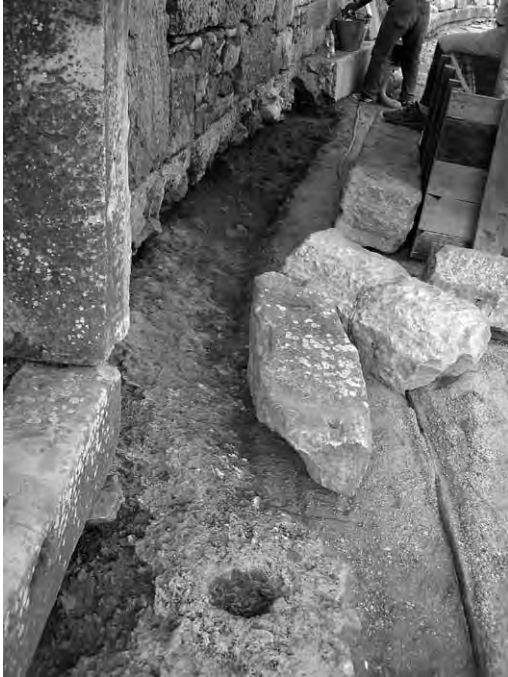
The block projection area on the ground was excavated to investigate the foundation of the pedestal blocks. In the areas near T17 a strong layer of bedrock was discovered (fig. 29), while in the other areas a soil depth of 40 cm was excavated to allow for a strong foundation wall which would also serve as a buffer between the blocks and soil. The excavated area was then filled by a foundation wall of approximately 25 cm width, and maximum 40 cm depth, running along the *diazoma* wall. The foundation wall was built using broken limestone pieces, and hydraulic mor-

29 Excavated area in front of the second *diazoma* wall revealing a foundation of conglomerate bedrock

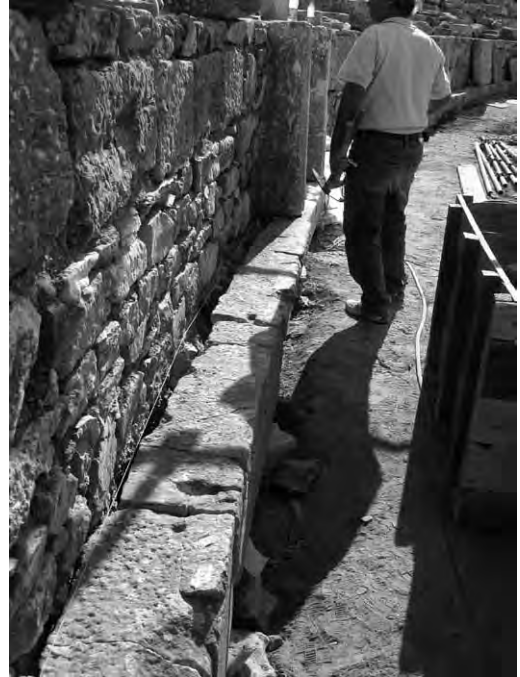
30 Process of placing the pedestal blocks back in their positions

tar as it was anticipated that the foundation wall would be subject to humidity. The blocks were then placed back in their documented locations (fig. 30).

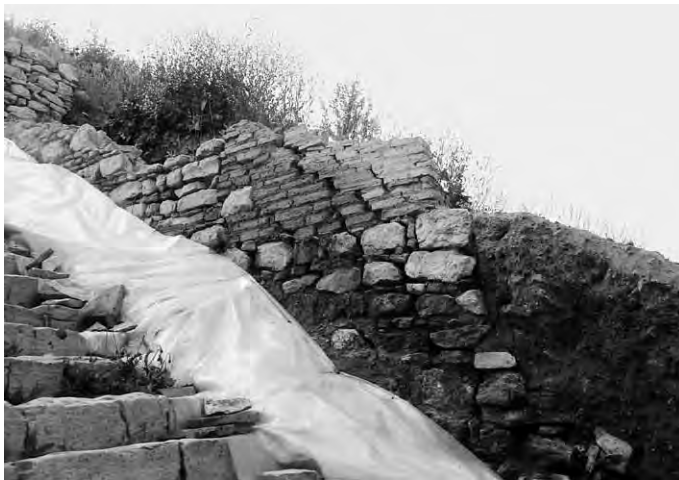
Capping and pointing work was performed on the wall to the south of the staircase. First observations on the wall revealed loss of joint mortar due to exposed wall cores, where rain water pooling and soil and organic material accumulation resulted in core deterioration and joint deterioration (fig. 31).

31 South wall of the area south of the Theatre, before work

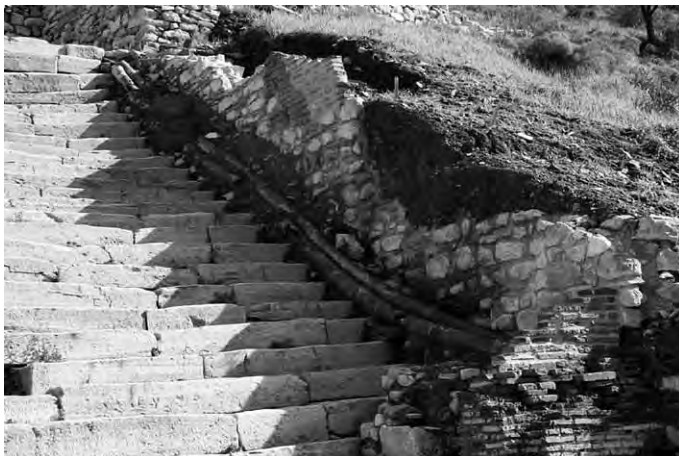
32 South wall of the area south of the Theatre, after consolidation

The initial interventions were the mechanical cleaning of loose debris and mortar from the area. Furthermore, the wall crowns were capped using hydraulic mortar. It was particularly important that no stones were added to the surface of the wall<sup>23</sup> and the joints are created in a such a manner that rainwater does not pool on the wall, but instead the water is directed to run off from the surface of the wall. After the capping intervention, the wall joints were pointed with mortar of the same composition (fig. 32).

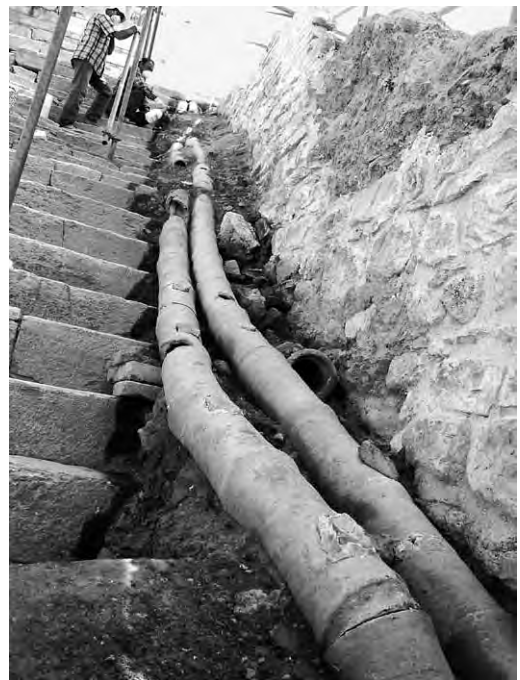
A system of two water pipes embedded in the original mortar, mixed with the spolia of the period has been discovered to have many broken fragments, and the mortar is very loose and powdering in several areas. It was decided to consolidate both the water pipes and original mortar to stop further loss of material.

33 Consolidation of the mortar of the water pipes with ethyl silicates

The original mortar was cleaned of very loose fragments using soft hair brushes and a low pressure air compressor. A colourless ethyl silicate was applied with soft hair brushes to the more sturdy areas and with light spraying on the flaking areas. The application took place layer by layer to ensure the best absorption of the ethyl silicate, and residue material on the surface at the end of the application was removed to prevent glazing (fig. 33).

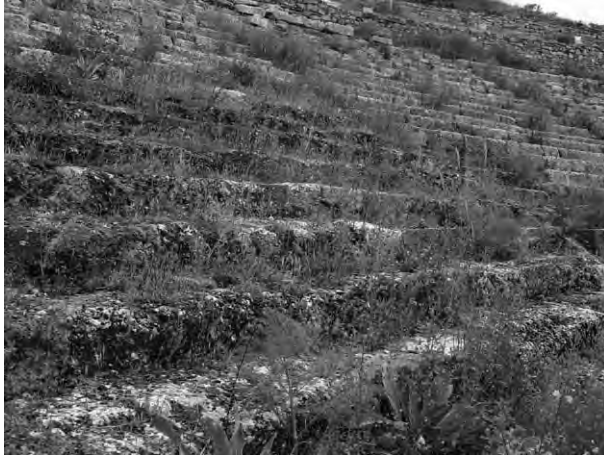
34 Conglomerate bedrock in *summa cavea* before consolidation

The natural cement of conglomerate bedrock which constitutes the substructure of the *cavea* cladding in *kerkides* S15 and S16 was found to have deteriorated due to soil accumulation, vegetation growth and biological matter (fig. 34). The first intervention entailed removal of the vegetation and soil accumulation on the material by means of mechanical cleaning. Biological cleaning was then performed using benzalkonium chloride solution in water. The material was then consolidated using ethyl silicates (fig. 35). The condition of the bedrock has improved since the 2009 season, and it is planned to replicate this intervention on the areas of bedrock surface in the *media cavea*.

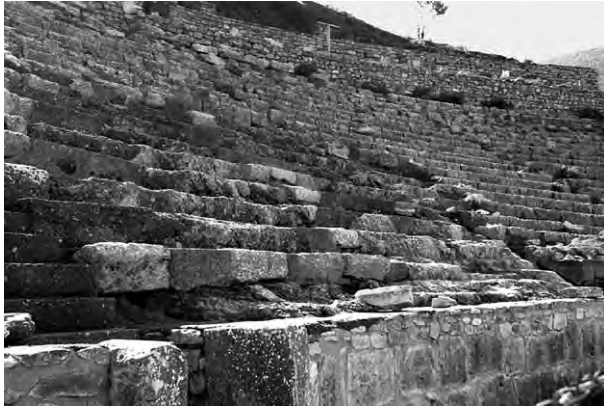
35 Conglomerate bedrock in *summa cavea* after cleaning and consolidation

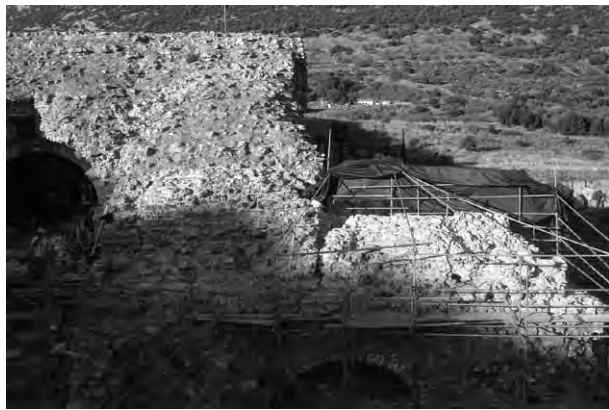
40 View of the area above the S1 vault after the cement-based capping was stripped

The first item on the South Analemma Project is the consolidation of the area above S1 vault, where the deteriorated cement-based capping has eroded and given way to water damage. The interior of the vault also showed signs of mortar loss and joint erosion (fig. 39). Work has started simultaneously both on the vault and on the capping. In both areas, cement-based or loose mortar has been stripped (fig. 40). A new capping with a mortar composition determined by the reports of Istanbul Technical University in 2006 and rubble stone has been implemented on the area. Inside the vault, pointing work and mortar injections<sup>24</sup> have filled the gaps in the structure. This work was completed in the 2010 season (fig. 41).

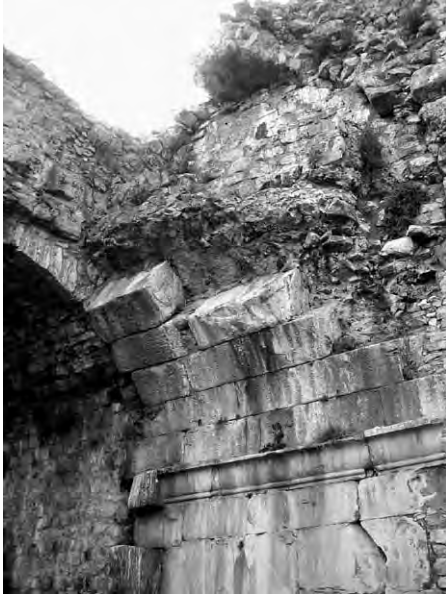
42 Marble vault blocks in the south *analemma* in danger of collapse

The second area on the South Analemma Project requiring attention was the three layers of vault blocks on the corridor S1 which presented a danger of collapse (fig. 42). The centre of gravity of the blocks was located outside the line of the wall, and the blocks were being held in place by friction. These blocks have been anchored in place through 1.20 m long anchors connected by stainless steel bars of 50 mm by 5 mm, and points of contact have been insulated with neoprene layers. As the blocks have been fastened and secured, it is now possible to approach the southern front of the S1 wall (fig. 43).

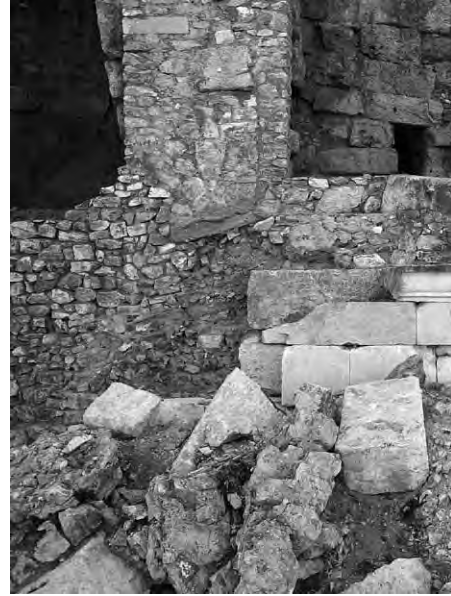
44 Rubble mass at the foundation of adjoining wall of south and north substructure chambers

The third position in the South Analemma Project consisted of the consolidation of the base of the wall between the northern and southern substructure chambers (fig. 44). Loose debris found under the base of the wall has been cleaned out to a breadth of 1 m and this section has been rebuilt using rubble stone and high strength mortar. Furthermore, a structural crack through the water channel was also investigated at this position. Joint movement indicators proved that there was no motion in the area: the deep crack was due to earthquake damage when the outer rim of the structure, built over man-made foundations, and the inner part of the structure, built on bedrock of the Panayırdağ, behaved differently producing a natural dilatation. Corresponding to the loose zone, this crack has also been consolidated and inaccessible points were filled through mortar injection (fig. 45).

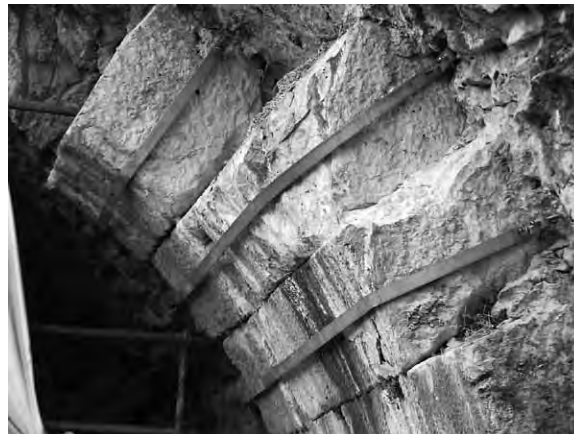
43 Three rows of arch blocks anchored in place

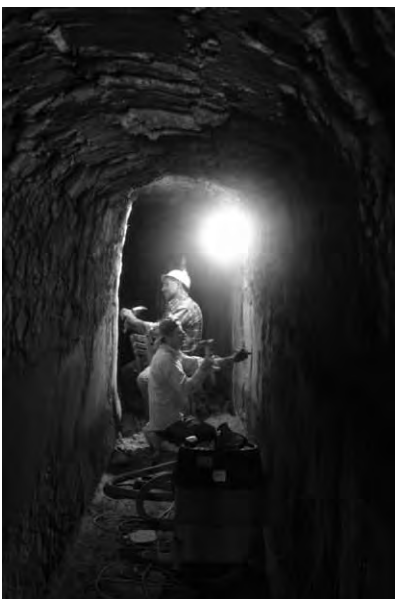
45 Consolidation work in the water channel below the substructure chambers of south *analemma*

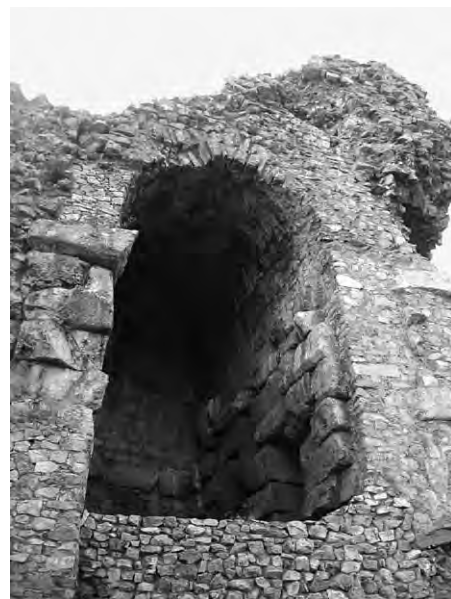
46 Northern substructure chamber with a deep crack running along the vault and back wall

The fourth position of the South Analemma Project was postponed to the 2011 season. This position involves the evaluation and consolidation of the vault of the northern substructure chamber (fig. 46). This also requires inspection through lifting the deteriorated capping above the vault, which is to be done in the 2011 season.

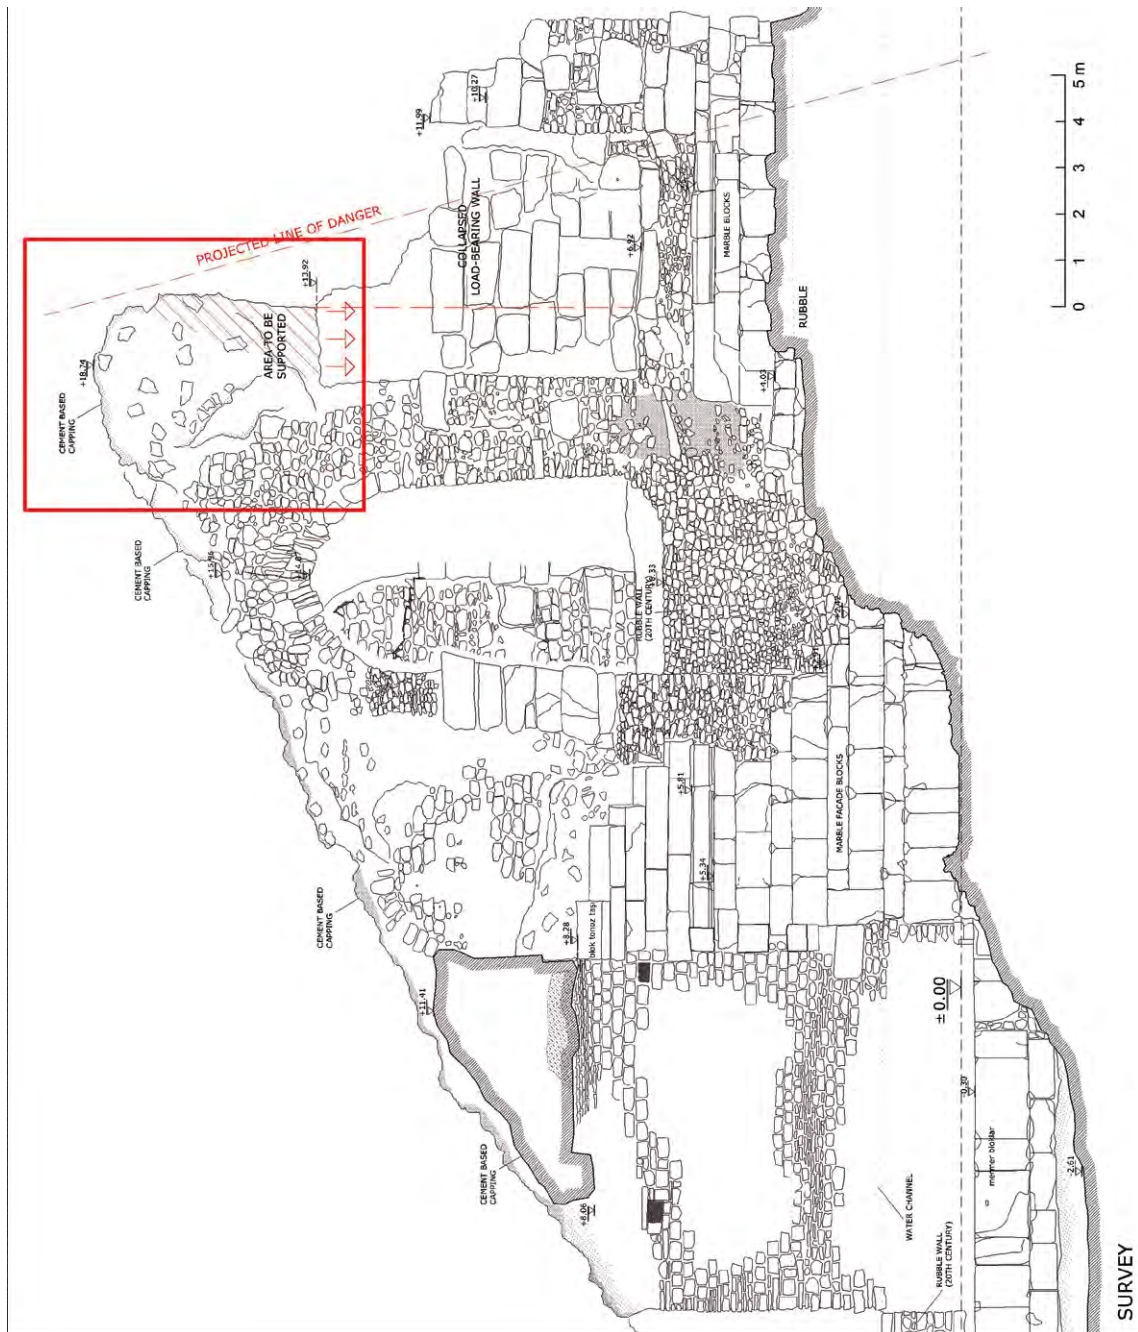
The fifth position of the South Analemma Project has been defined as securing the area beneath the broken vault of the southern substructure chamber, and securing the *in situ* portion of the vault in order to allow for further inspections and interventions (figs. 47, 48). Access to this area had been banned for several years, and presented any approach to this area presented serious security problems (fig. 49). The barrel vault of the substructure chamber was found to be partially collapsed due to the falling down of the load-bearing western wall of the chamber. Although joint movement indicators have not detected any motion in the area since 2006, presenting a state of equilibrium, the remains of the vault which were limited to the northern side of the room were found to be unstable in case of an earthquake or a shift in the balance. Further investigation of the structural problems of the substructure chambers and the area required a semi-permanent solution to be designed in order to be able to inspect the remains of the broken vault both from above and from below.

47 Problematic remains of the broken vault of the southern substructure chamber

The design process which started in June 2009 led to a stainless steel support structure much resembling the system of scaffolding. The support structure consists of pillars and connecting horizontal and diagonal bars fixed through specially manufactured nuts, bolts and plates (fig. 50). All of the materials mentioned are made of stainless steel grade 316. Impregnated and laminated wood blocks in different thicknesses are fixed to the support construction at the feet of the structure to ensure that the weight of the structure and the weight of the supported vault are evenly distributed by the 8 feet of the structure to the uneven ground surface (fig. 51).

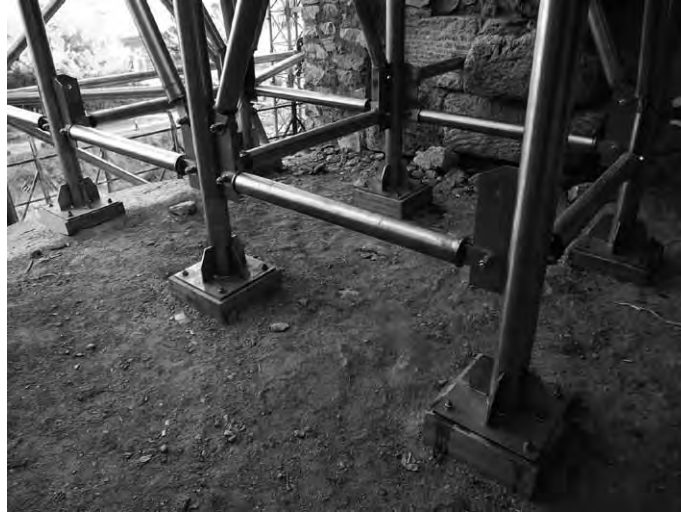
51 Detail from the feet of the support structure
