Quentin Devers

## An Archaeological Account of Nyarma and its Surroundings, Ladakh\*

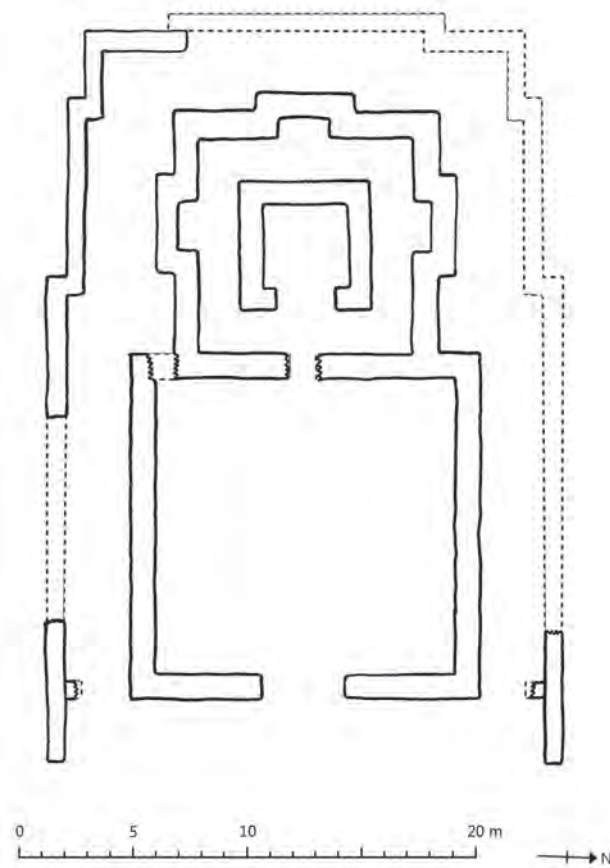
7. Reconstruction of the original plan of Temple 1 (Q. Devers, 2012).

Some elements allow for reconstructing the missing walls of the ambulatory. In Fig. 8, in *b* and *c* the tips of walls 5 and 9 are not coated, and they are made with bricks that have a rougher texture, with pebbles inside like those of walls 6, 7 and 8. Walls 5 and 9 were as such very likely a single wall that was cut at *b* and *c* in order to build room E. In *d*, the mud-coat on the tip of the wall indicates that it ended there, while in *e* a break in this coat shows that the wall protruded here. From there, if we consider that the temple was symmetrical, then we can reconstruct the walls all the way to wall 10, as shown on Fig. 7. In *a* and *j* the mud coats are continuous: walls 4 and 11 had as such no protruding counterparts from walls 2 and 3.

on Fig. 7): while these walls were still standing in 1965 as can be seen on Fig. 4, they have now dissolved into the ground. A possible scenario is that on the completion of this installation large quantity of water likely ended up rushing to the complex, where it had nowhere to escape, as the topography goes slightly uphill in all directions, provoking an increase in the size of the pond which dissolved the base of walls 15, 16 and 17, resulting in turn in their eventual collapse.

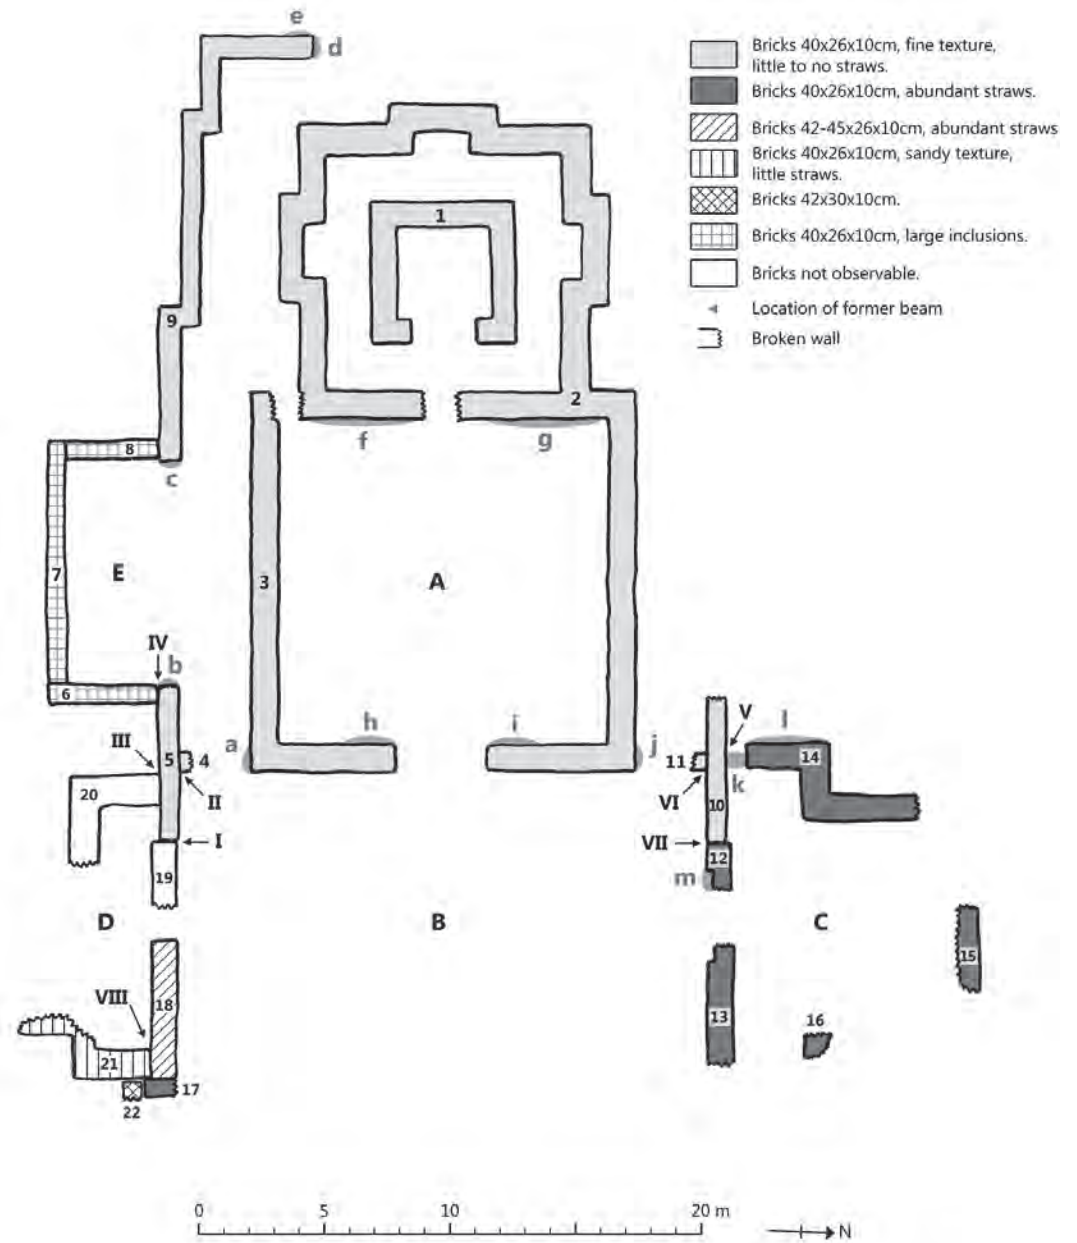
8. Plan of Temple 1. Roman numerals indicate specific mud-coat marks and grey lower-case letters locations referred to in the text (Q. Devers, 2012).

Temple 1 is composed of several parts (Fig. 8): there is a central temple (A), an ambulatory around it visible only on its southern flank with a room opened in it (E), and a large open space in front of it (B) framed on both sides by two chapels (C and D). The central temple (A) is in turn composed of a large assembly area, opening on the west on an inner ambulatory that contains a central cella. A small temple was built in the relatively recent past (most probably in the 1840s, see Jahoda, "Joseph Thsertan Gergan's report on Nyarma, 1917", this volume, p. 175) above this cella and above part of the inner ambulatory, as can be seen in Fig. 9.

In Fig. 8, the walls are differentiated according to their chaining, and according to the traces of mud coats. For example, the sections of wall 2 are chained together, making it one long single wall. On the other hand, while they are straight and contiguous, walls 5 and 19 are not the same,

because the external mud coat of wall 5 goes all around its tip at its juncture with wall 19, thus separating them. In addition, in Fig. 8, the walls are coloured according to the size and texture of the bricks.

The original plan is easily visible: it is drawn by the walls coloured in light grey (walls 1, 2, 3, 4, 5, 9, 10 and 11). It is made with 40 x 26 x 10 cm bricks that have a fine texture without straw inside.

The study of the mud coats corroborates this plan: in II and VI they tie these original walls together (walls 4 and 6 on the one hand, 10 and 11 on the other), while in I, III, IV, V and VII they clearly separate them from those added later. The preserved walls are about 4 m high.

The external top of the entrance walls has small marks of a porch roof (Fig. 8: small holes on the upper part of wall 3). However, given the later development that took place in front of the temple (see below) one must remain cautious as to whether these marks are

In a second phase, a development took place in front of the temple with the construction of a large space (B) along with at least one lateral chapel (C) (Fig. 8). Another chapel was likely on the other side of space B, but, as we will see, in its current state it is not from the same period as chapel C.

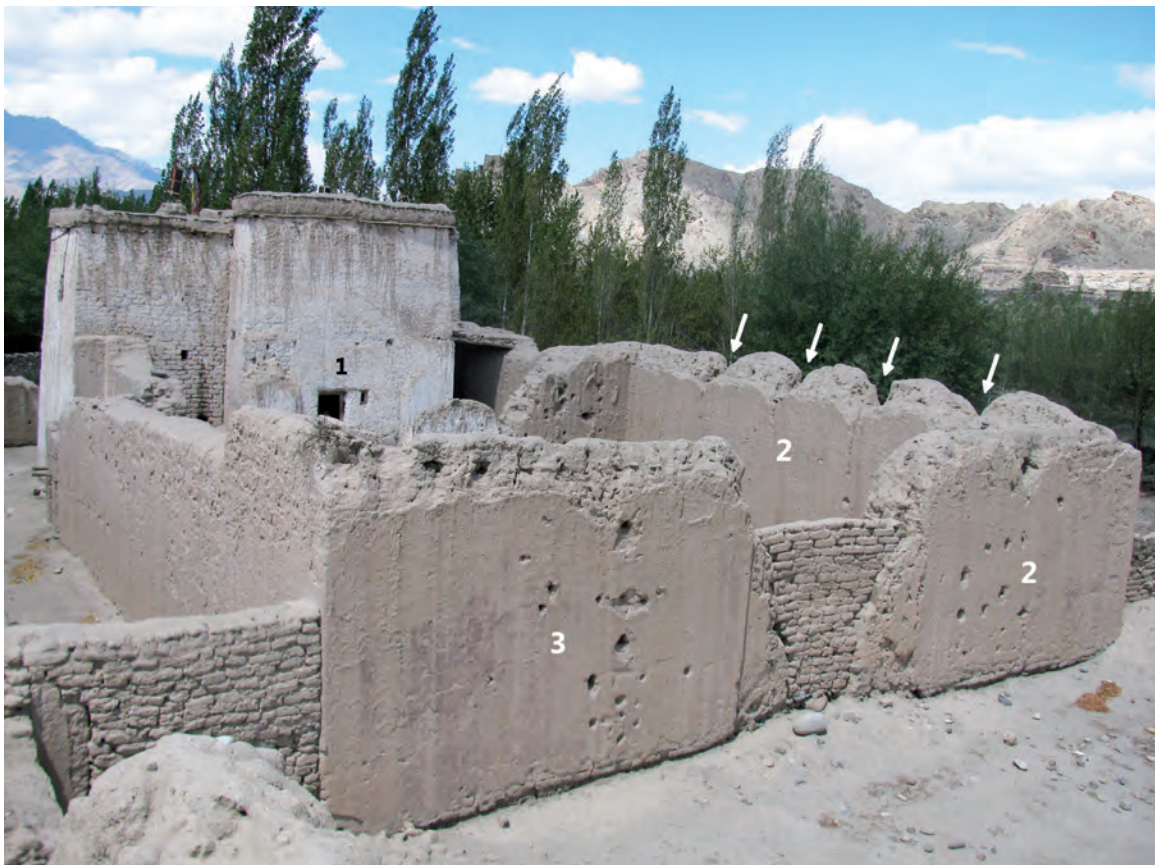
9. Assembly area of Temple 1 from south-east. Numbers indicate the walls numbers according to Fig. 8. The white arrows show the recesses where the beams used to fit on wall 2. The opposite wall has its top levelled (wall 3) (Q. Devers, 2009).

The positions of the beams that once supported the roof of the assembly area are still visible: they correspond to the vertical recesses at the top of the walls. There were four of these, about 2.5 m apart (Fig. 8: indicated by the small grey triangles in wall 2; Fig. 9: indicated by the white arrows). These can be seen only on wall 2: the upper part of wall 3 was levelled (Fig. 9).

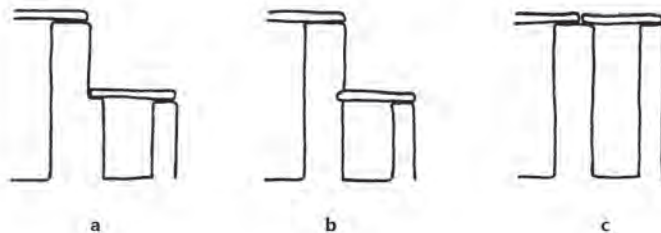
10: Different types of deambulatory roofing. After original drawings by Martin Vernier (Q. Devers, 2012).

The roof of the ambulatory is more difficult to assess. Like wall 3, the tops of walls 5 and 9 were levelled, and, as the rest of the ambulatory wall is missing, no trace of a roof is left. If there was one, it could not have been lower than that of the temple: it would have otherwise required either a wall with a recessing profile (Fig. 10: *a*) or a wall with holes to fix the beams (Fig. 10: *b*)—the walls of the temple are straight and without holes. As such, if the ambulatory had a roof, the only possibility is that it was at the same height as that of the temple, as illustrated in *c* in Fig. 10.<sup>5</sup>

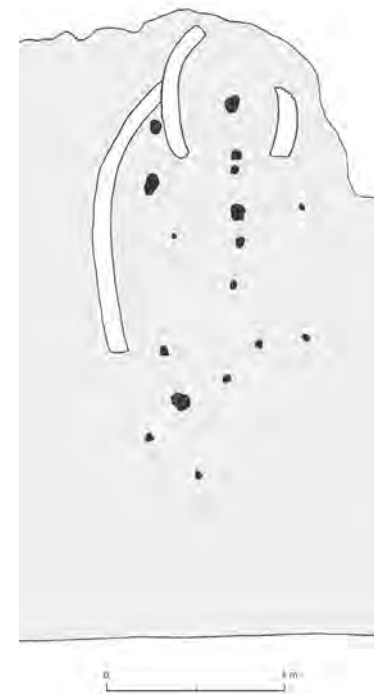
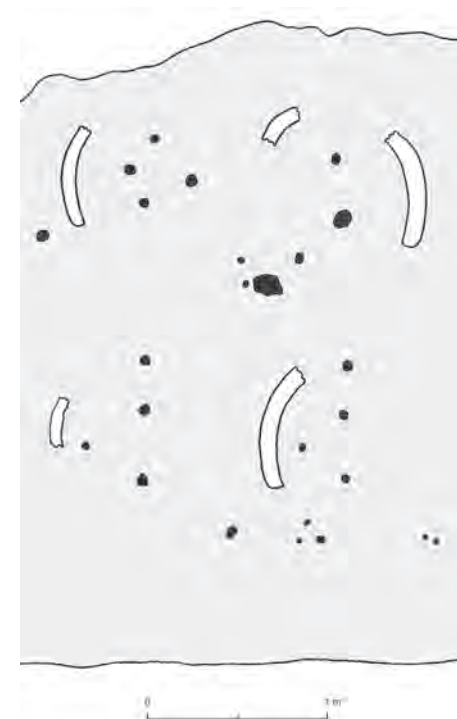
11. Temple 1: drawing of the halo in *i*. Scale approximate. The halo is in white, holes in the wall are in black (Q. Devers, 2012).

12. Temple 1: drawing of the halos in *g*. Scale approximate. The halos are in white, holes in the wall are in black (Q. Devers, 2012).

There are two sets of halos visible on the walls of the assembly area, and a third inside the central cella.<sup>6</sup> The first set consists of a large halo on either side of the main door, at *h* and *i* in Fig. 8. They are 1.5 m wide (Fig. 11). The second set of halos is in *g*. It has four smaller halos, 80 cm wide, in two registers (Fig. 12). The lower halos seem to have had three vertical fixings with another one on the left near the halo. The holes of the upper halos are not as clear, they seem to have had fewer fixings spread in a different fashion. The elevation of the wall in *f* is missing: as such the existence of another four halos is a matter of speculation. A third set composed of at least one small halo can be seen on the back of the central cella (wall 1).

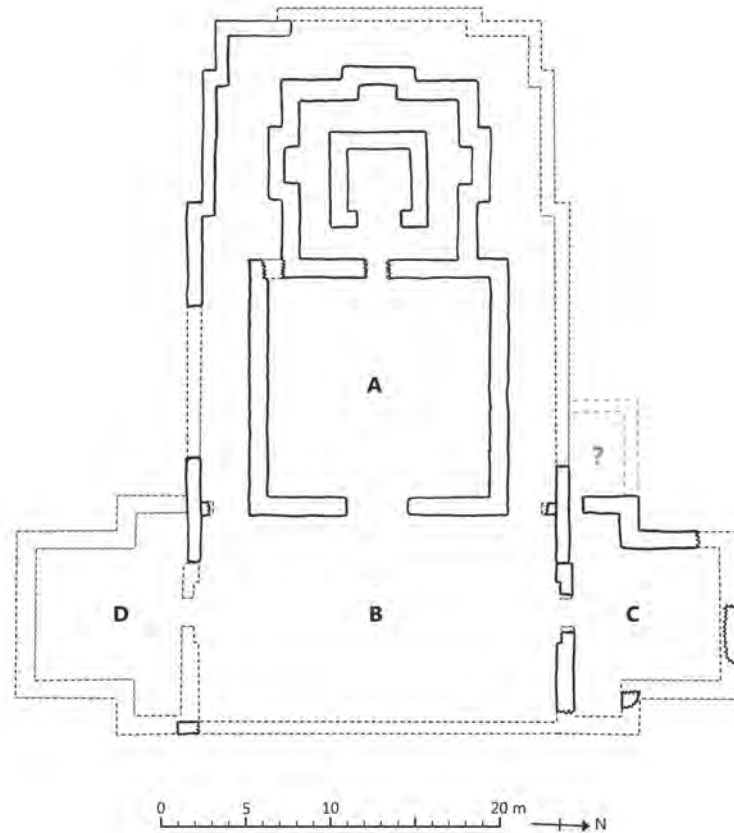
15. Temple 1: reconstruction of space B, chapel C, possible room north of chapel C and possible original chapel D (Q. Devers, 2012).

As there is no direct relationship between walls 12-13 on the one hand and walls 14-15-16 on the other, it is questionable to state whether the development of space B is contemporaneous with that of chapel C. But the fact that they are made from the same bricks, and that walls 12-13 use special bricks shaped with a recess in order to fit a doorframe (Fig. 13) indicates that it was designed with a door right from the beginning. As such, chapel C is likely contemporaneous with space B.

Two elements in chapel C are worthy of discussion. First, an opening in the wall suggests that there was a narrow door about 80 cm wide leading outside of the chapel in *k*. The second element is that in *l* wall 14 has no external mud coat, whereas the rest of the wall does. These two elements raise the question of the existence of a former room there. Fig. 15 shows a possible reconstruction of this stage with the hypothesis of a chapel in D similar to that in C, and with the hypothesis of an adjacent room north of chapel C.

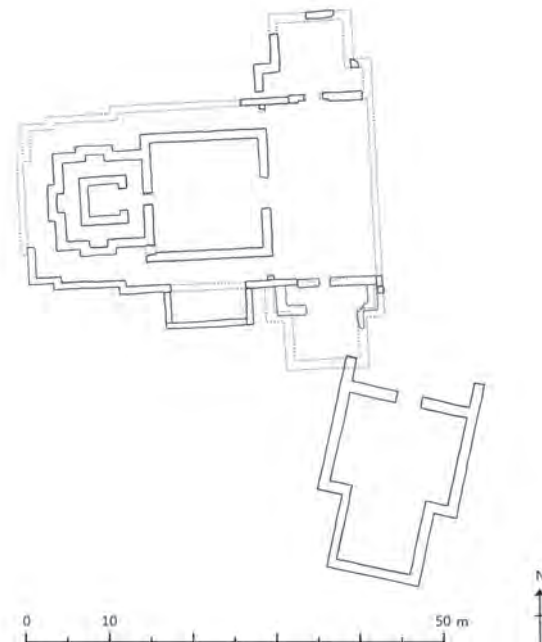
17. Temple 1: possible reconstruction of original Chapel D in relation to Temple 2 (Q. Devers, 2012).

As we will see, the modifications of chapel D have to be considered in relation to the construction of Temple 2. Indeed, if it was originally similar to chapel C it would have overlapped with Temple 2 (Fig. 17).

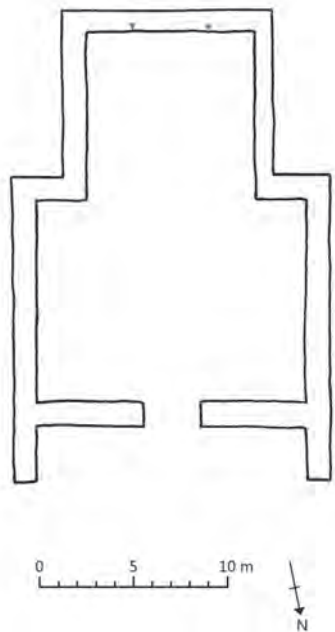
20. Plan of Temple 2 (Q. Devers, 2012).

Its walls do not exhibit clear signs of stucco halos or of fixation holes, except maybe for one hole that goes right through the rear

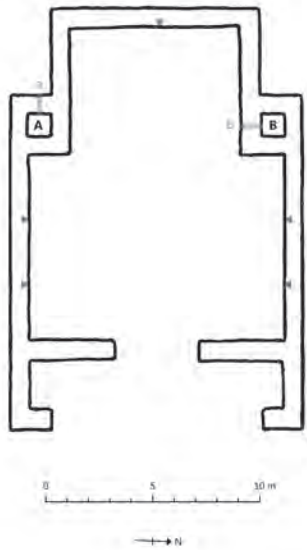
25. Plan of Temple 5 (Q. Devers, 2012)

Temple 5 is the southernmost in the complex (Fig. 21 and 26). Its walls are 90 cm thick, built with bricks that are 40–42 x 26 x 10 cm. The porch shows signs of the beams of its former roof both on the side walls and on the entrance walls. In addition, a series of vertically aligned small holes can be seen in the left corner (Fig. 27). The door jambs are straight. The roof of the assembly area was supported by two beams about 3 m apart, 2.6 m from the entrance wall and 3 m from the rear wall. The rear niche, which has walls 5.9 m high rather than 4.6 m for the assembly area, appears to have had one beam. The inner walls do not show clear signs of stucco halos or of fixation holes. The access to the two closed rooms on each side of the rear niche (A and B on Fig. 25) is open to question: the room on the right

can be seen only through a hole in the wall in *a*, while one on the left can be entered only through a hole at the base of the wall outside in *b*. As of now it is not possible to state whether these holes are original or if they were added later on, raising the issue of whether the interior of these rooms was designed to be accessed or even seen.

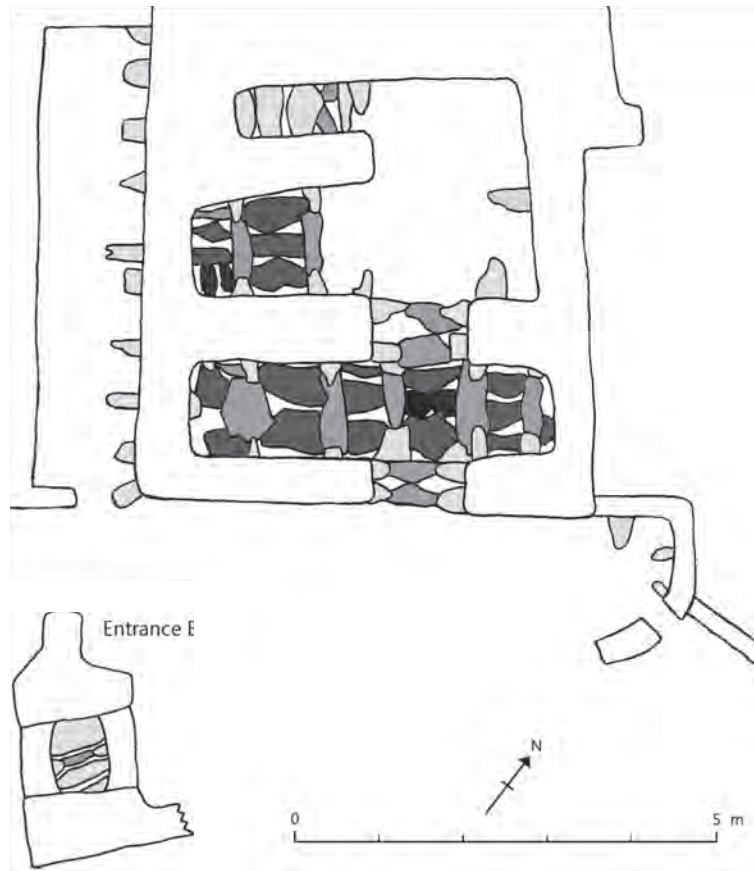
35. The three structural levels of the stone roof in the fort: corbels (light grey) support lintels (mid-grey), supporting in turn another level of lintels (dark grey) (Q. Devers, 2012).

corbels was either destroyed or dismantled before being replaced by the current one. This restored space D was then either left open or roofed with wooden beams resting on the corbels of the main building on one side, and on top of the new wall on the other.

In large buildings, this type of stone-roof is undoubtedly ancient. The main reason is the constraint of layout it imposes: rooms need to be very narrow. However, this type of roofing had a more perennial use in smaller structures, in which rooms did not need to be more important, the most common of which were the *mchod rten*. This longer use in smaller structures is also noted by Bellezza in Upper Tibet (Bellezza, personal communication, Nov. 10, 2010).

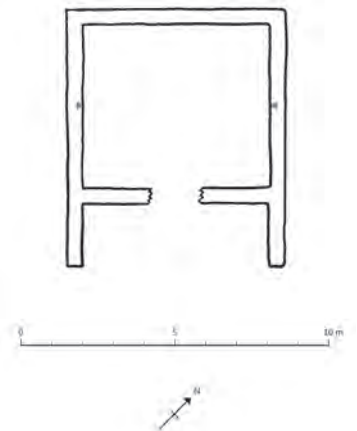
44. Thikse-Nyarma: plan of Temple 1 (Q. Devers, 2012).

This stands immediately after the rocky formation (Fig. 44 and 45). Built of some of the longest bricks I have measured in Ladakh—52 x 22 x 10 cm—its walls are quite thin compared with those of the main complex: they are only one brick thick, i.e. 55 cm when adding the thickness of the mud coat.<sup>14</sup> They are 4.9 m high. The shape of the door jambs is not visible, both having deteriorated. The right half of the porch is marked with a line of small holes on the entrance and side wall (Fig. 44). The roof of the temple was supported by one main beam in the middle of the side walls. There are still stones in the recesses into which the timber used to fit, protecting the bricks from the pressure it created. These stones show the width of the former

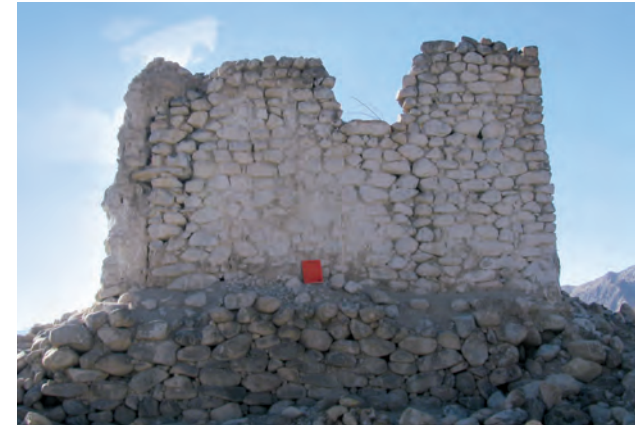
49. Thikse-Nyarma: Temple 2 from the south-east. The porch wall in bricks can be seen on the left, with a stone in the middle that sticks out of the masonry to penetrate into it (Q. Devers, 2010).

Temple 2 is the least well preserved; its walls are falling to pieces. Due to their degradation, their thickness is now variable, from 50 cm to 70 cm, for a height of 2.2 m. Except for the front façade, the walls do not have an external mud coat. Its door is very narrow and low—only 55 cm wide and 1.15 m high. Its frame is decorated with four successive recesses, the outermost of which is T-shaped (Fig. 47[a]). Its intact mud coat conceals the material used for the lintel of the door. Only one small porch wall protrudes on the right: made of bricks, it is possibly a later addition. However, from the side one can see one long stone sticking out from the masonry to penetrate into the bricks: this may be an indication that although it is made of brick it is contemporaneous with the temple (Figs. 48 and 49).
