9. THE HOUSES H1 TO H5

9.1. THE HOUSES H1 TO H3¹⁷³

9.4. SUMMARY AND RECONSTRUCTION OF THE HOUSES H1 TO H5 (Fig. 16)

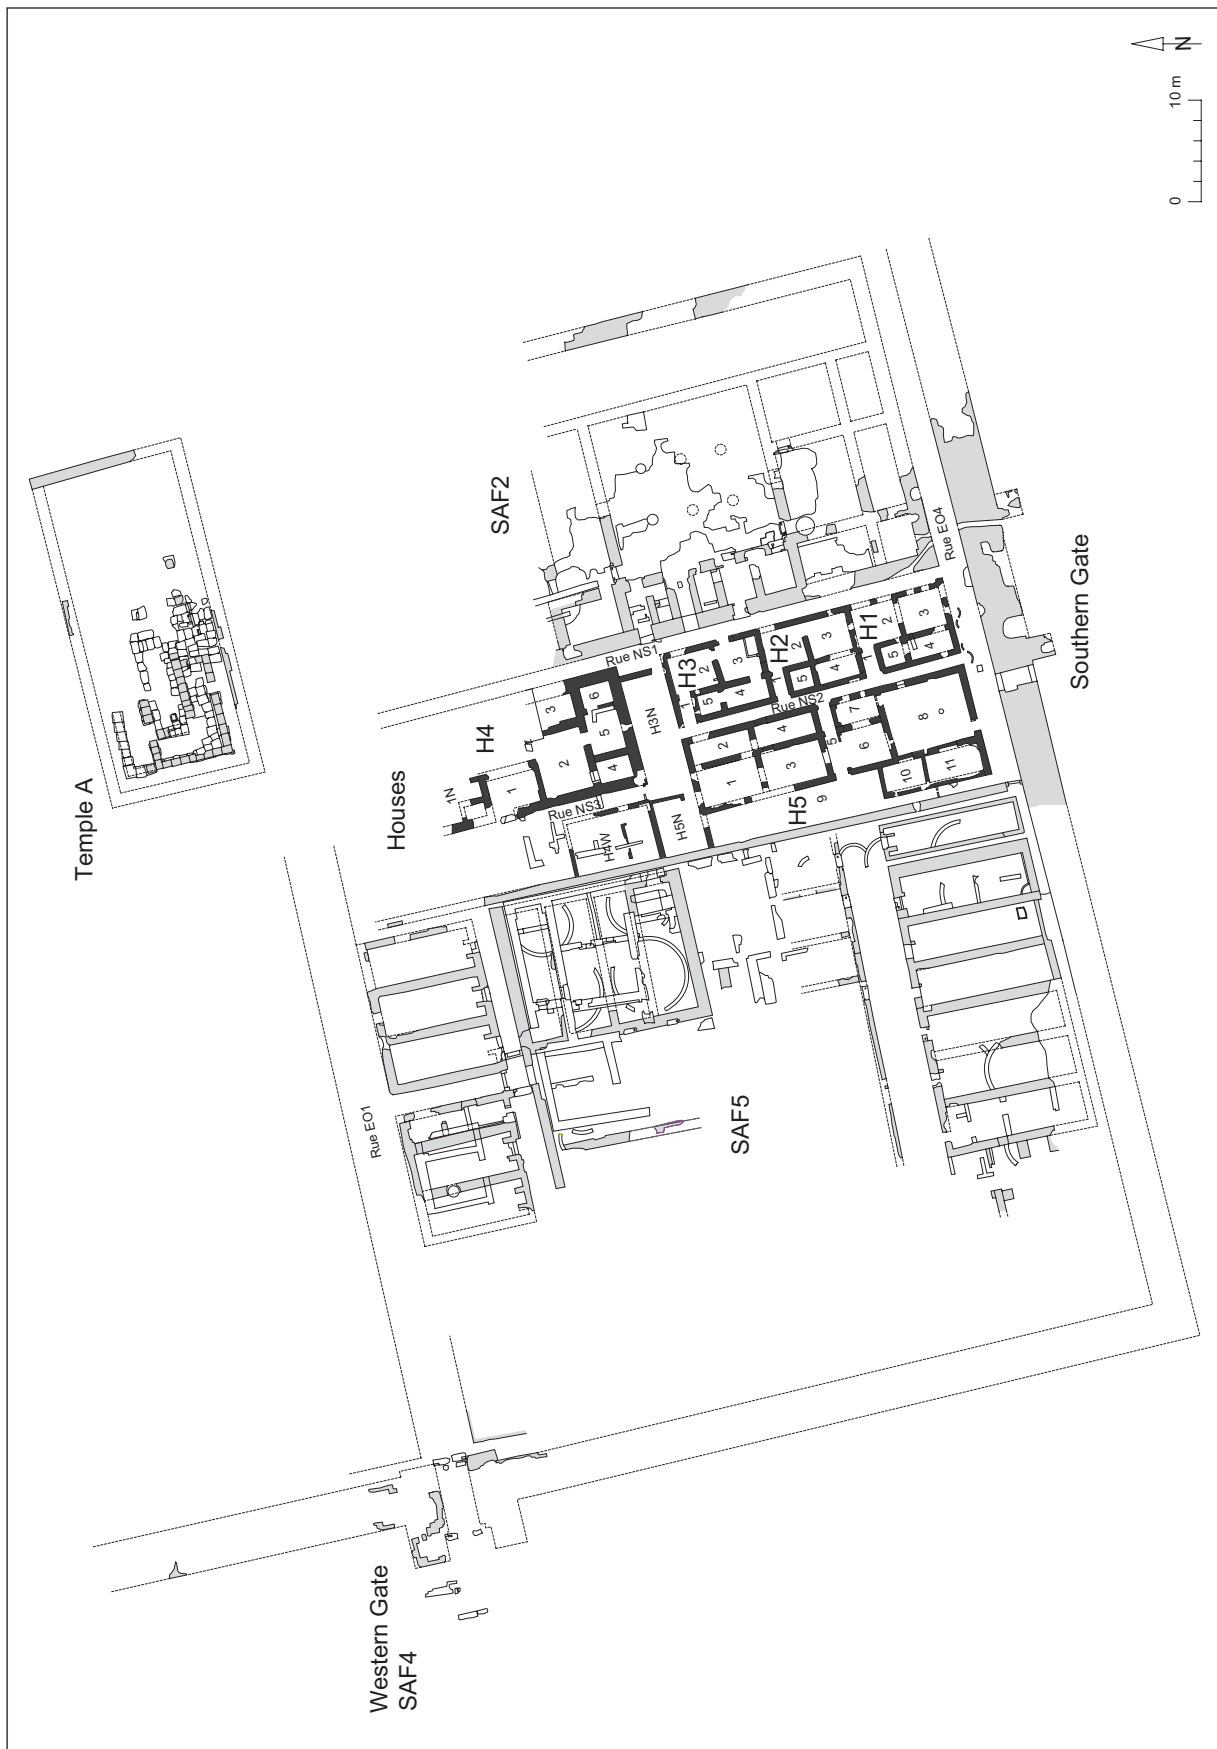
(Fig. 15)

The houses H1 to H5 (Pl. 36.1) are located in the central part of the excavated area SAV1 and are flanked by the streets Rue NS1 in the east, the reconstructed Rue EO1 in the north, and Rue EO4 in the south. On the western side, a north-south oriented wall separates the residential quarter from the magazines in the west. The five houses comprise a total area of 1,273m², with a north-south extension of 64.50m and an east-west extension of 19.66m. It must be noted, however, that the northernmost part of House H4 does not exist anymore and one can only assume that it formerly had reached to Rue EO1 in the north.¹⁶⁸ The houses were erected in a strict orthogonal grid, with the walls perpendicular to each other.

Fig. 15. Overview of the houses H1–H5

Overall, the walls of the houses are standing up to the height of about 1.0m, though the condition of the walls in the south is generally less well preserved. Here, at House H1 and the southern part of House H5, only around three to four courses of bricks have survived, reaching a maximum height of 0.50m. Some of the walls can only just be seen as a slight elevation protruding from the ground surface. It is therefore sometimes difficult to detect whether the wall continued onwards or may have incorporated a doorway.¹⁶⁹ Also, the lowest courses of the walls were commonly laid without doorways being marked, so when the upper brickwork has been lost, the pattern of access across the continuous lengths of wall often cannot be identified clearly.¹⁷⁰

The houses H1 to H3 are situated to the west of the main north-south thoroughfare Rue NS1 and are aligned in a row from the south to the north. They are designed as row houses, always sharing the dividing wall. The three houses all have approximately the same layout and size, consisting of five rooms: two main rooms in the east and two smaller rooms and an entrance room in the west. With an area of c. 55.0–58.0m² the houses are rather small in size.¹⁷⁴ The access of the rooms followed a spiral-form pattern¹⁷⁵ beginning from the entrance room 1 and ending in room 5. The main entrance to the houses

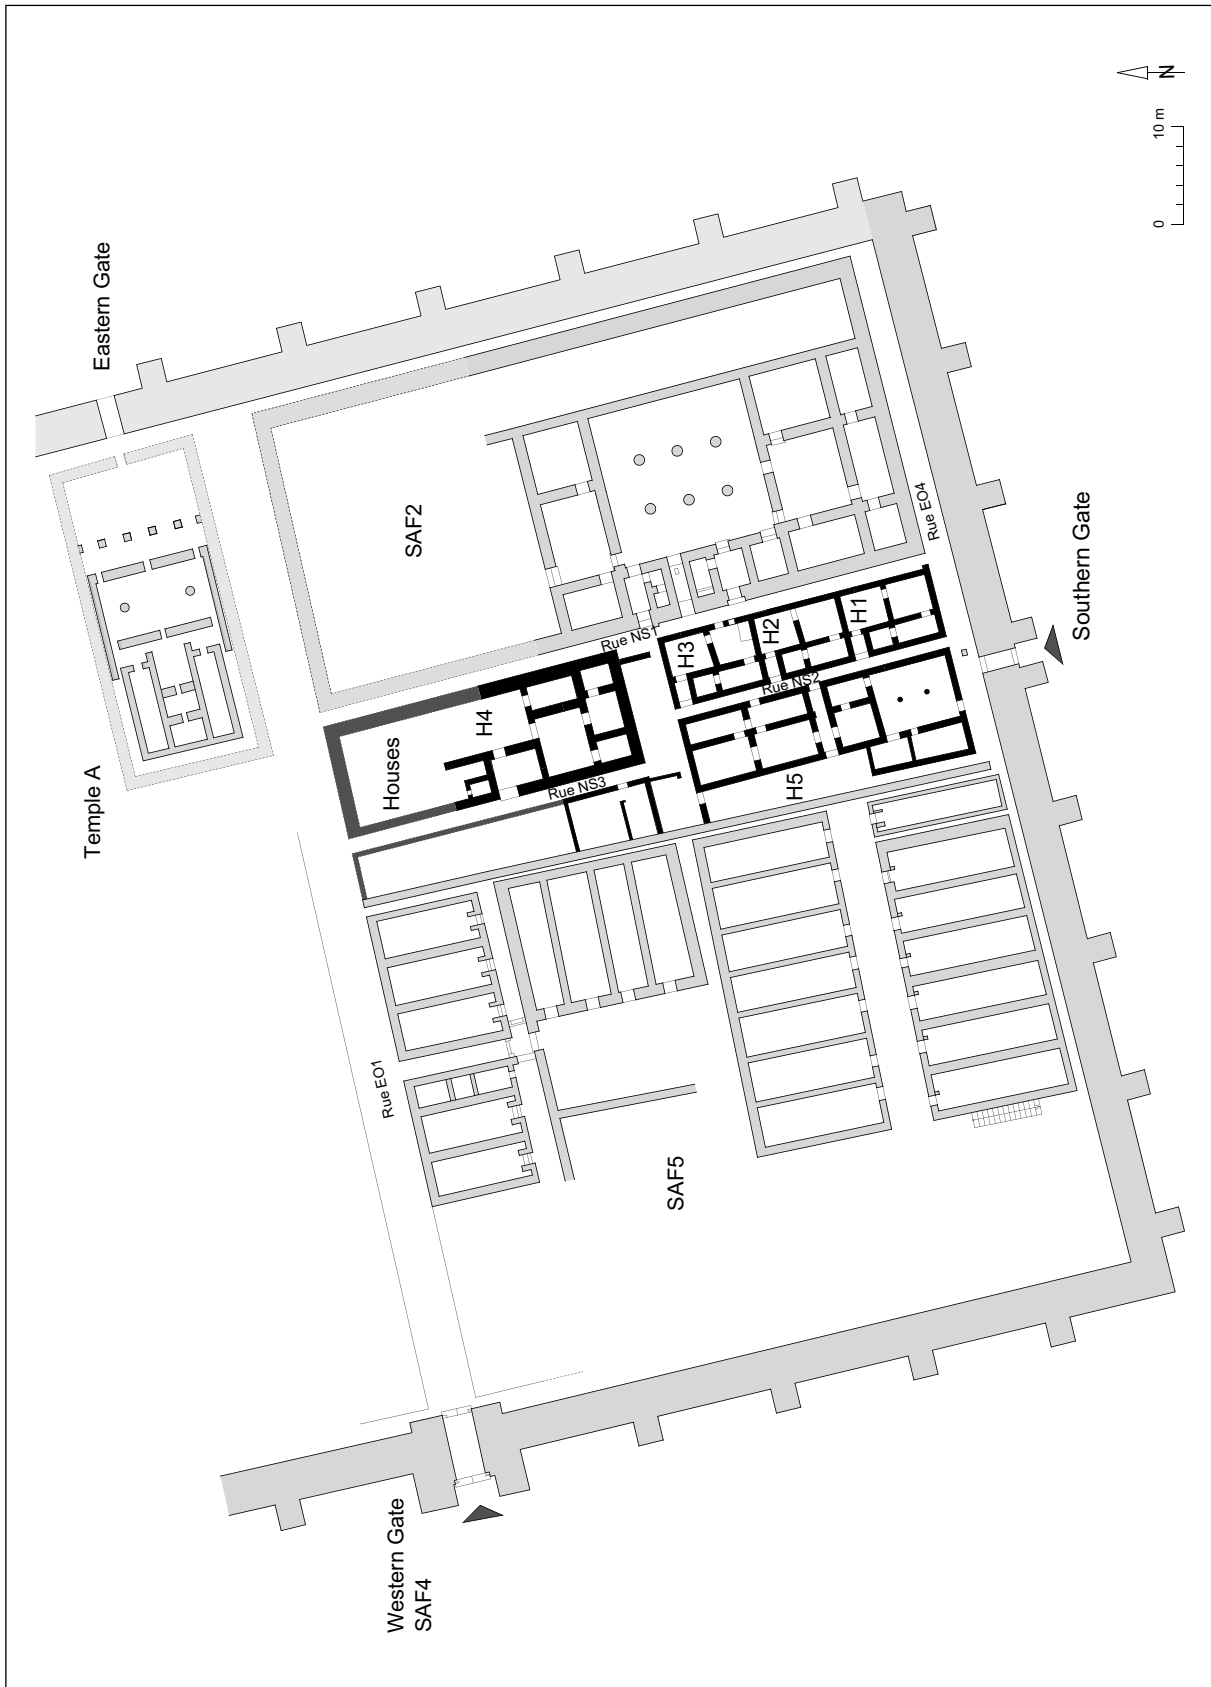
The domestic area in the center of SAV1 consisted of five dwelling units which were all arranged in the orthogonal grid that defined the southern part of the town. The assumed main accesses into the houses occurred from the north-south oriented corridors Rue NS2 and Rue NS3. The houses H1–H3 are row houses with an almost identical ground plan, with two main rooms in the east and two smaller rooms and the entrance corridor in the west, leading from the entrance in a spiral-form to the most private room.²²⁵ The neighboring house H5 consisted of a central corridor and nine rooms, situated to the north and the south of the corridor. In the west was an open courtyard. From the ground plan of the house it seems possible that H5 actually comprised two separate dwelling units, divided by the corridor. In this case, the northern house would consist of two larger rooms in the west and two elongated smaller ones in the east. The southern house possessed one main room in the south, probably equipped with columns, and four smaller rooms. The access to these two smaller houses would have been from the central corridor.

Fig. 16. Reconstruction plan of the houses H1–H5

In the north of the residential sector was House H4, separated from the houses H1–H3 and H5 by an open area. Only the southern part of House H4 is preserved; it is however assumed that the dwelling reached to the main street Rue EO1 in the north. In the still existing part of the building, the main entrance could be detected in the west, on the longitudinal side of the house. The entrance room was followed by five further rooms of varying sizes, with the southernmost rooms aligned in a row.

As for the 3-D reconstruction of the domestic quarter (Pl. 58), one of the main problem is once again the former height of the buildings and especially the question of the existence of upper stories.²²⁶ As already addressed, the thickness of the walls do not necessarily indicate a possible upper floor. In fact, all the walls in the domestic area would have been strong enough to support one.²²⁷ However, no remains of staircases could be found in the entire area of the domestic buildings. Therefore, the houses H1–H3 and H5 are reconstructed as single-story houses with flat roofs, always spanning the entire building block.²²⁸ Parapet-walls of a height of about 0.50m enclosed the roof surface.²²⁹ If the houses had any windows apart from the single example in House H3, can no longer be determined; if windows were present, they were of small format and must have been situated higher up in the walls.²³⁰ As alternate sources of light and ventilation, openings in the roof or even roofless rooms also seem plausible.²³¹
