# I. INTRODUCTION

by Julia Budka

## 1 THE NEW KINGDOM TOWN OF SAI ISLAND

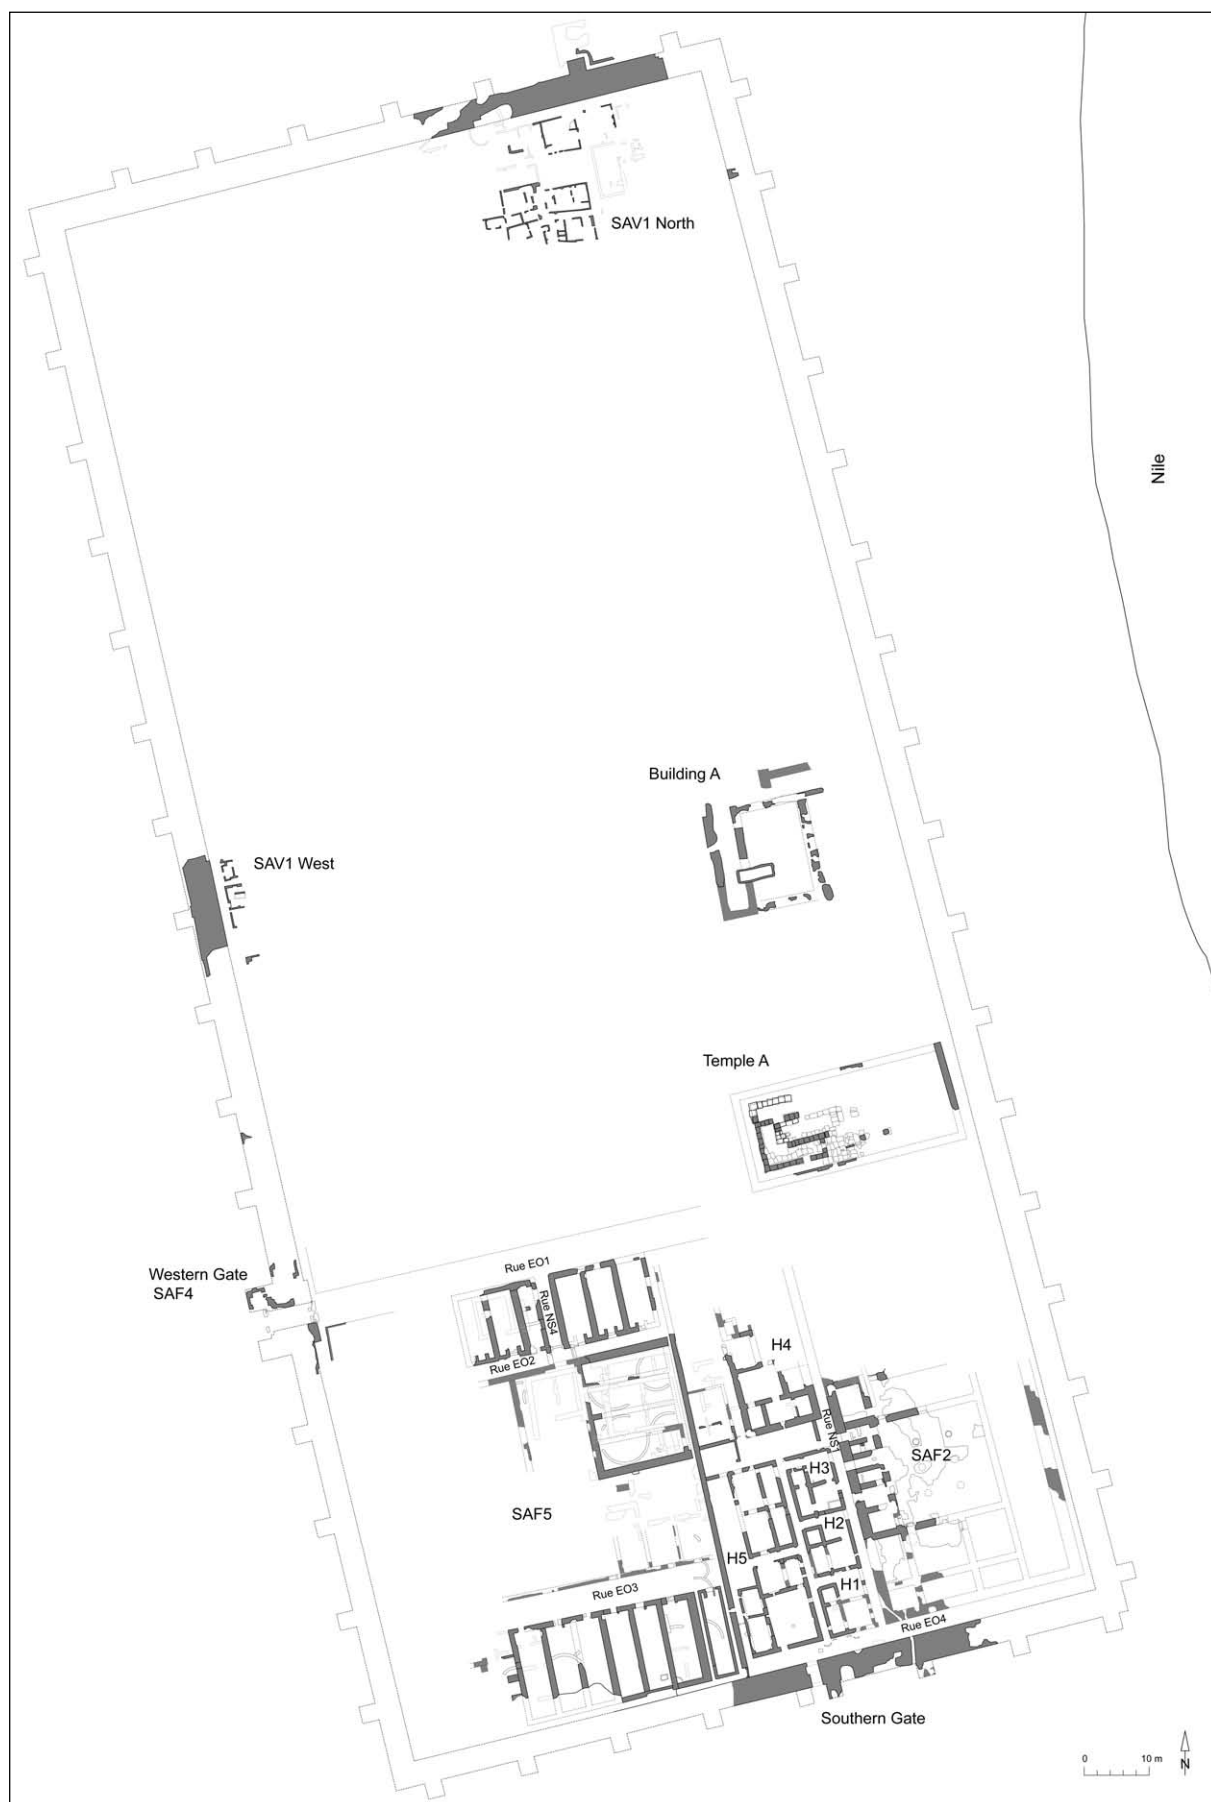
Fig. 1 Map of the New Kingdom town of Sai, including field work results up to 2016 (©AcrossBorders, Ingrid Adenstedt)

The fortified Pharaonic town was built on the eastern bank of the large island of Sai in the New Kingdom (Fig. 1, Pl. 2). The town has the shape of a fortified settlement with an orthogonal layout, measuring 238m north–south and 118m east–west, with a total of 27,600m (2.76 ha).<sup>9</sup> In the southern part of the town (SAV1) different quarters were identified in the course of fieldwork by Michel Azim:<sup>10</sup> a palatial or residential quarter (sector SAF2) with a surface area of 2,020m;<sup>11</sup> a central domestic quarter H comprising a cluster of five houses; and a western quarter (sector SAF5), consisting of several rectangular storage rooms and circular silos from an earlier phase.<sup>12</sup> These quarters reflect the orthogo-

As presented in Chapter II by Florence Doyen, the architectural remains documented in SAV1 North are markedly different to the ones uncovered by Michel Azim in the southern part of the town.<sup>47</sup> Rather, the remains in the northern sector find close parallels in SAV1 West and contrast strongly with remains at SAV1 East (Fig. 1).

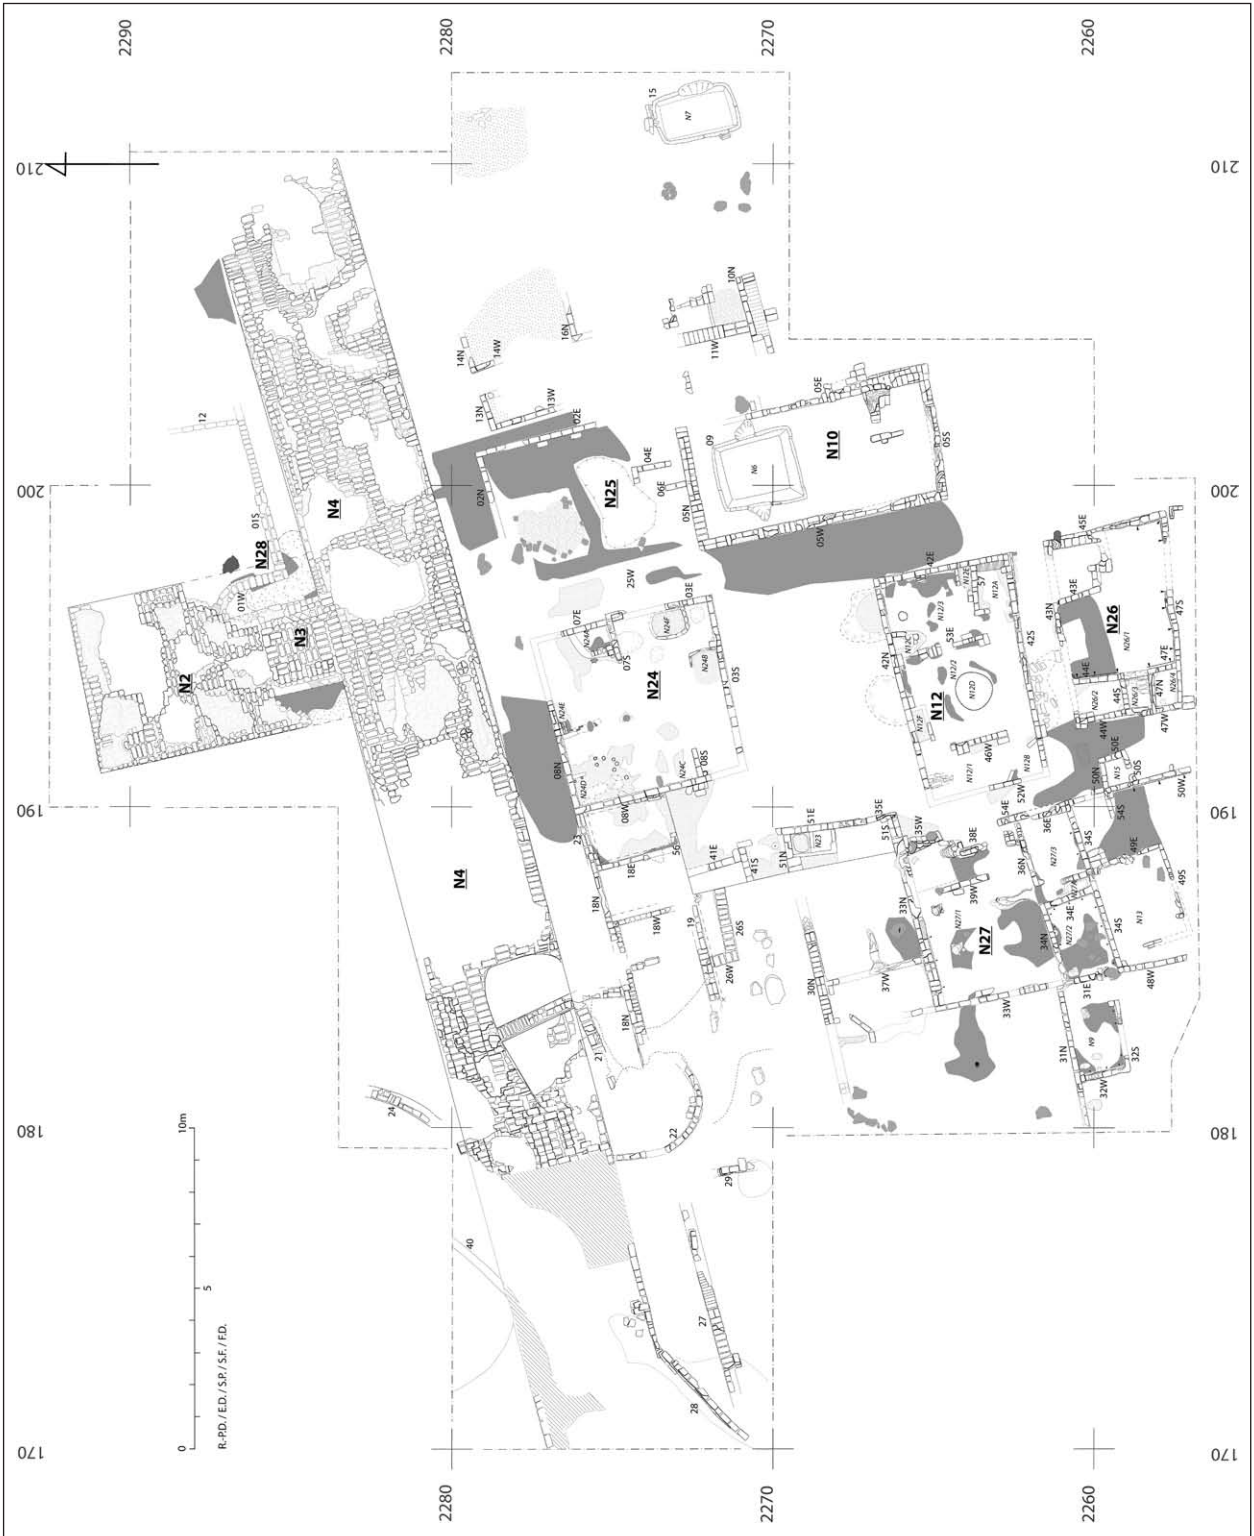
Fig. 3 Complete plan of the site SAVI North

From 2008–2012, fieldwork was conducted by the Sai Island Archaeological Mission (SIAM) of Lille 3 at a site named SAV1 North, along the northern enclosure wall, unearthing remains dating back to the early 18<sup>th</sup> Dynasty (see IIIH).<sup>17</sup> Nine 10m squares were excavated in SAV1 North (Fig. 3, Pl. 3). Sections of Enclosure Wall N4 as well as several mud brick structures of Egyptian type were exposed and documented. Preliminary reports on these buildings have already been published;<sup>18</sup> the structures of Level 3 are described here in Chapter II.

As the earliest evidence of occupation in SAV1 North, Level 5 was exposed in Square 180/2270 (Fig. 3) just above the natural soil.<sup>35</sup> It was partially excavated in a small area enclosed by the sections below Walls 18N, 18W and 26S/26W (see Fig. 3).<sup>36</sup> Despite the lack of any architectural remains, archaeological material from the deposits such as ceramics and some small finds allow the attribu-

Apart from some incomplete structures,<sup>42</sup> two similar architectural features (N6 and N7) belong to the phase of Level 2 (Fig. 3). N6 and N7 are storage pits of a square to rectangular shape, cut into the natural ground soil. The pits are carefully lined with mud bricks and plastered at their interior, obviously a scheme to preserve the pit contents.<sup>43</sup> N6 is located within building unit N10, which is orientated north–south along a narrow lane (Fig. 3). N10 illustrates that most of the preserved walls from buildings of Level 2 are one brick thick. Some of these bricks display marks on their large rectangular surface, well attested already in Level 3 (see IIA.3).

At SAV1 North, a minimum of five structures can be reconstructed in the excavated part for Level 3. House N12 (see IID) is one of the better preserved buildings of this phase (Fig. 3). It was fully excavated in 2011 and attests to the presence of typical Egyptian tripartite houses on Sai in a rather small scale.<sup>48</sup> With an internal surface area of about 27m, N12 is considerably smaller than examples of tripartite houses at Elephantine<sup>49</sup> or from the workmen’s village at Amarna.<sup>50</sup> Within Nubian fortresses, though, tripartite houses of small size are attested since the Middle Kingdom (e.g. at Uronarti and Buhen).<sup>51</sup> However, the houses from SAV1, the southern sector of the New Kingdom town of Sai, are all considerably larger than N12; at a bit more than 50m, Houses H1–H3 are the smallest within this group and nicely compare to houses in the Amarna workmen’s village. Houses H4 and H5 have a surface area of more than 300m,<sup>52</sup> comparable to some of the houses from the Amarna main city.<sup>53</sup>
